# OLD BISBEE HIGH LOFTS

DESIGN REVIEW BOARD  
APPLICATION PACKAGE  
SUBMISSION

100 CLAWSON AVENUE  
BISBEE, ARIZONA 85603

APRIL, 2023

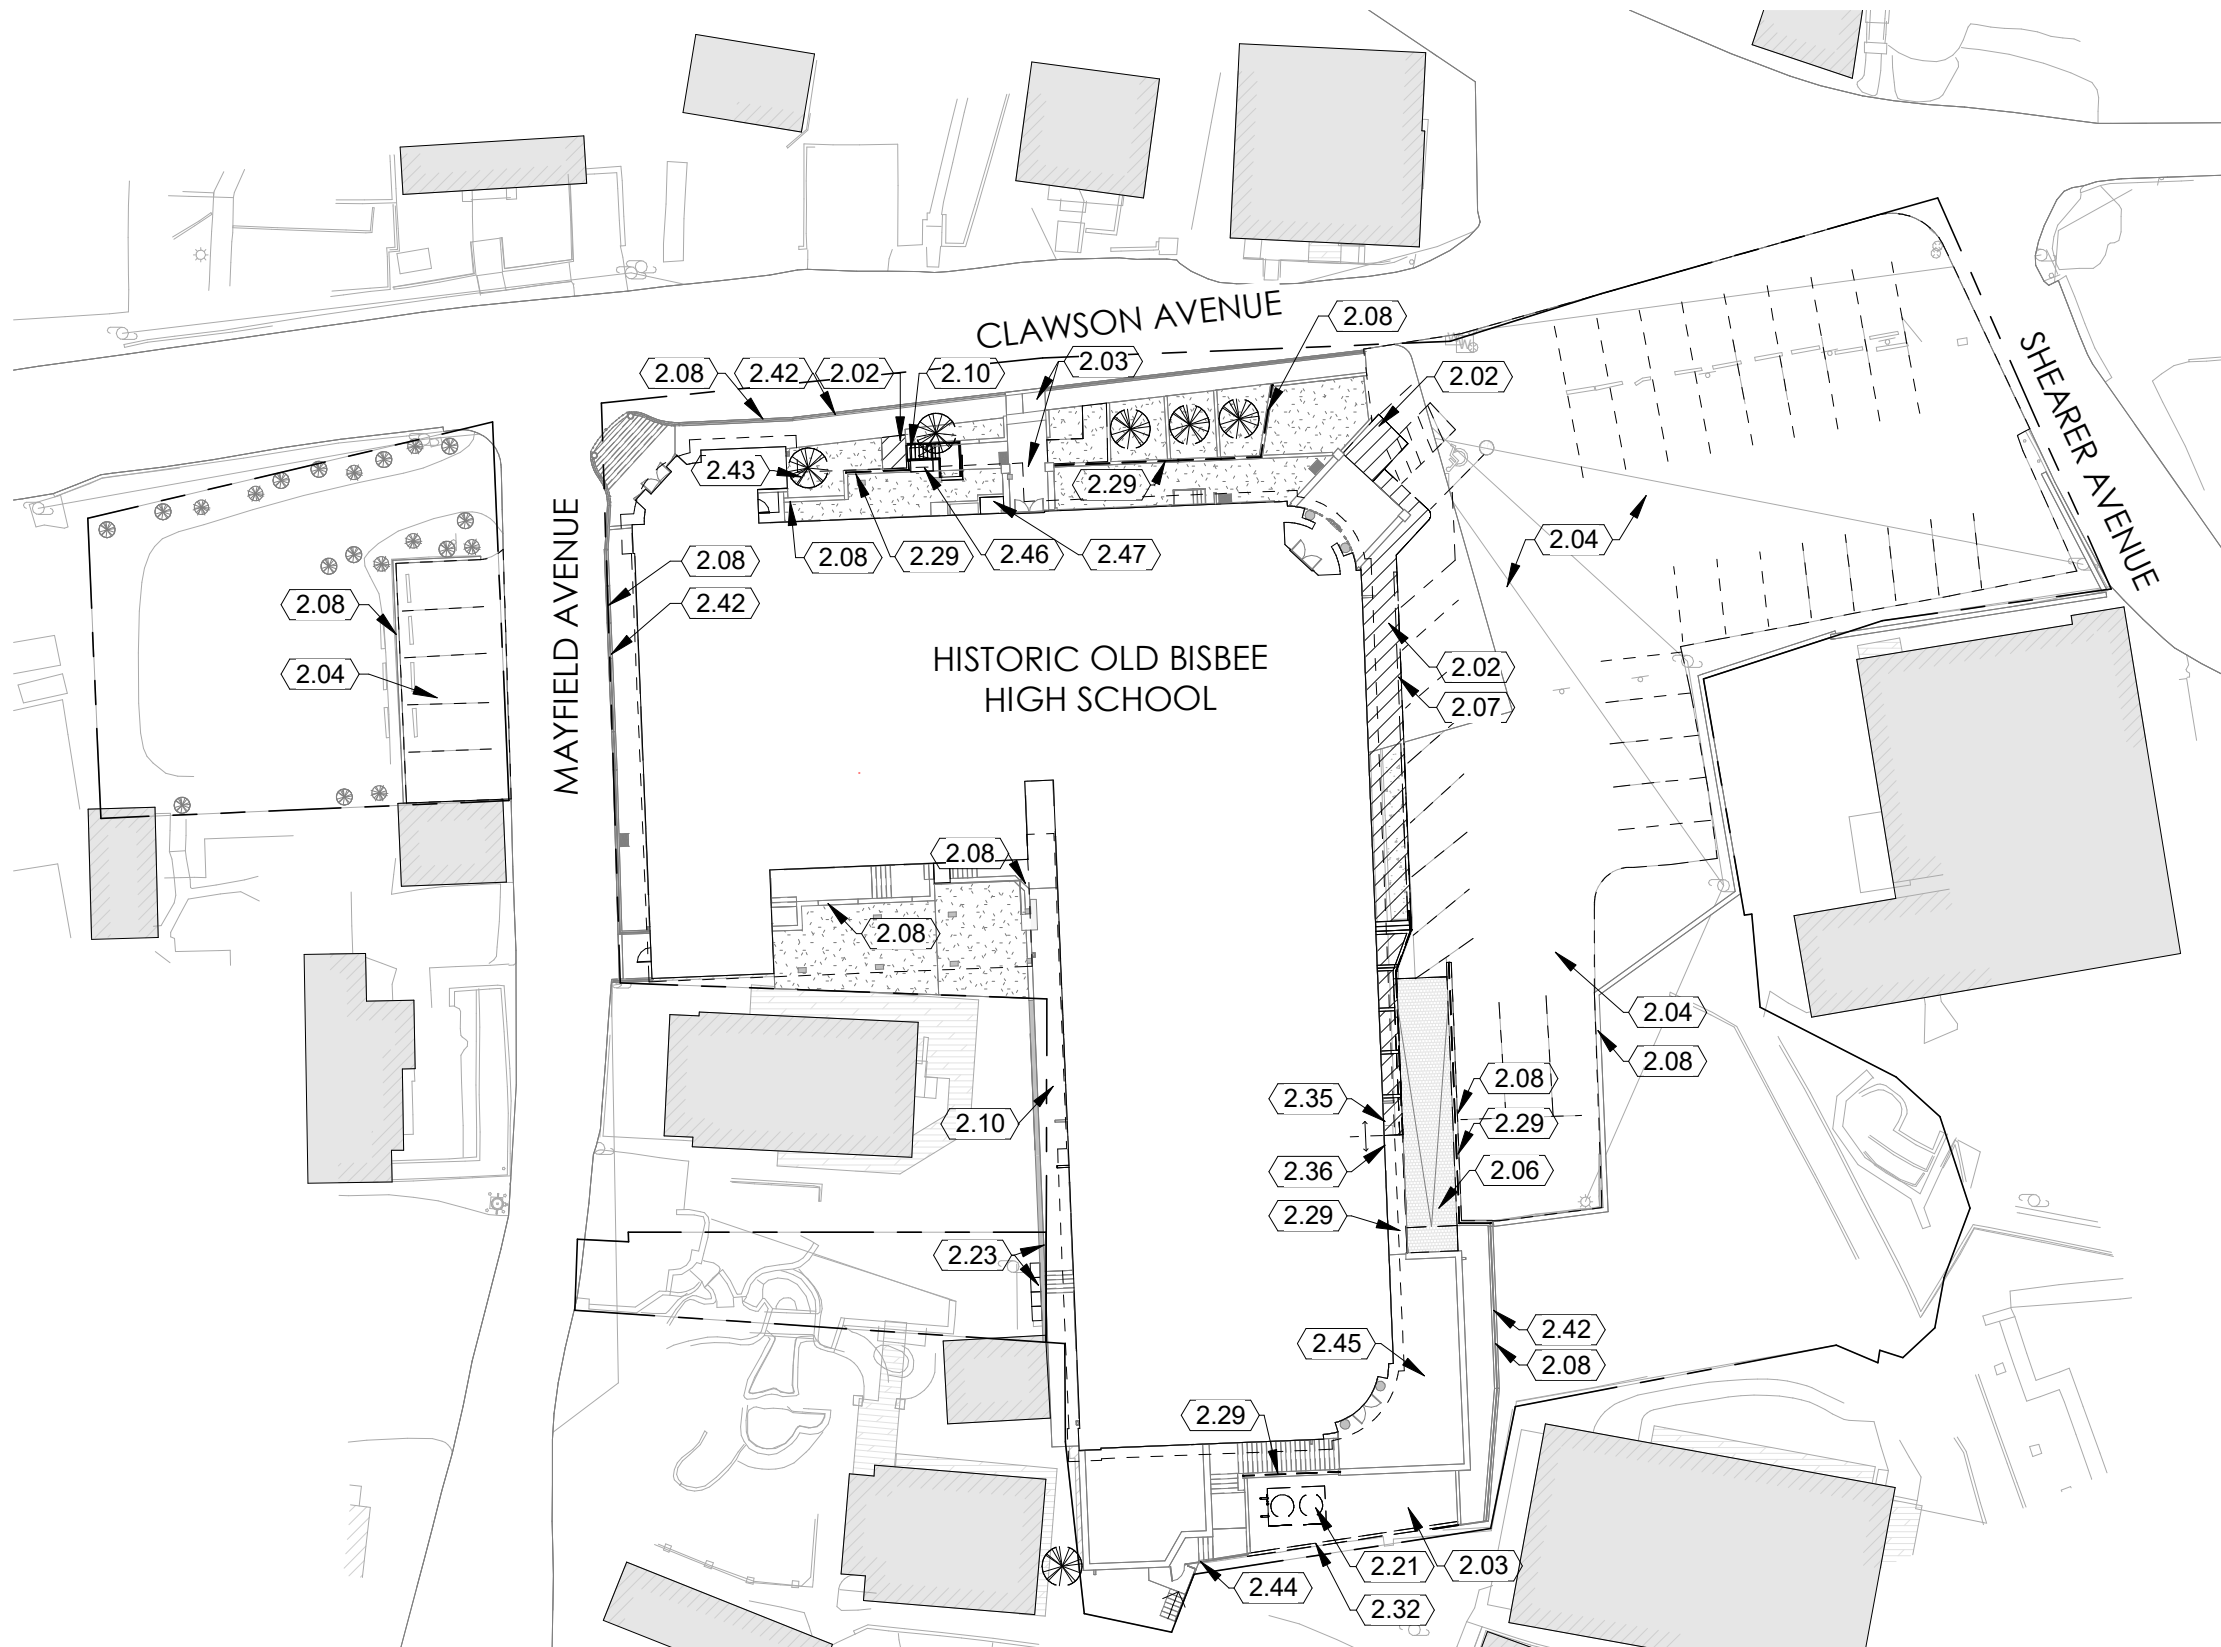
- KEYNOTES
- 2.02 EXISTING CONCRETE SIDEWALK TO BE DEMOLISHED
  - 2.03 EXISTING CONCRETE SIDEWALK OR EXTERIOR SLAB TO REMAIN/ BE PRESERVED - INSPECT FOR REPAIR/REPLACEMENT AS REQUIRED

- 2.04 EXISTING PAVING TO BE DEMOLISHED
  - 2.06 EXISTING BRICK PAVING TO BE REMOVED + SALVAGED FOR RE-USE PER THE NEW WORK
  - 2.07 EXISTING CONCRETE CURB TO BE DEMOLISHED

- 2.08 EXISTING CONCRETE RETAINING WALL TO REMAIN/ BE PRESERVED - INSPECT FOR REPAIR AS REQUIRED
  - 2.10 EXISTING EXTERIOR STEEL STAIR AND ASSOCIATED STRUCTURE AND RAILINGS TO BE DEMOLISHED

- 2.29 EXISTING STEEL RAILING TO BE DEMOLISHED - SEE NEW PLANS FOR REPLACEMENT
  - 2.32 PORTION OF CMU ENCLOSURE WALL TO BE DEMOLISHED
  - 2.35 EXISTING ELEVATED CONCRETE SLAB AND ASSOCIATED SUPPORT WALLS TO BE DEMOLISHED TO THE EXTENT SHOWN - SEE STRL

- 2.36 PORTION OF EXISTING ELEVATED CONCRETE SLAB AND ASSOCIATED SUPPORT WALLS TO REMAIN/ BE PRESERVED
  - 2.42 EXISTING STEEL PIPE RAILING ALONG RETAINING WALL TO REMAIN AND BE PRESERVED FOR REHAB - NOTE PORTIONS THAT REQUIRE EXTENSIVE REPAIR

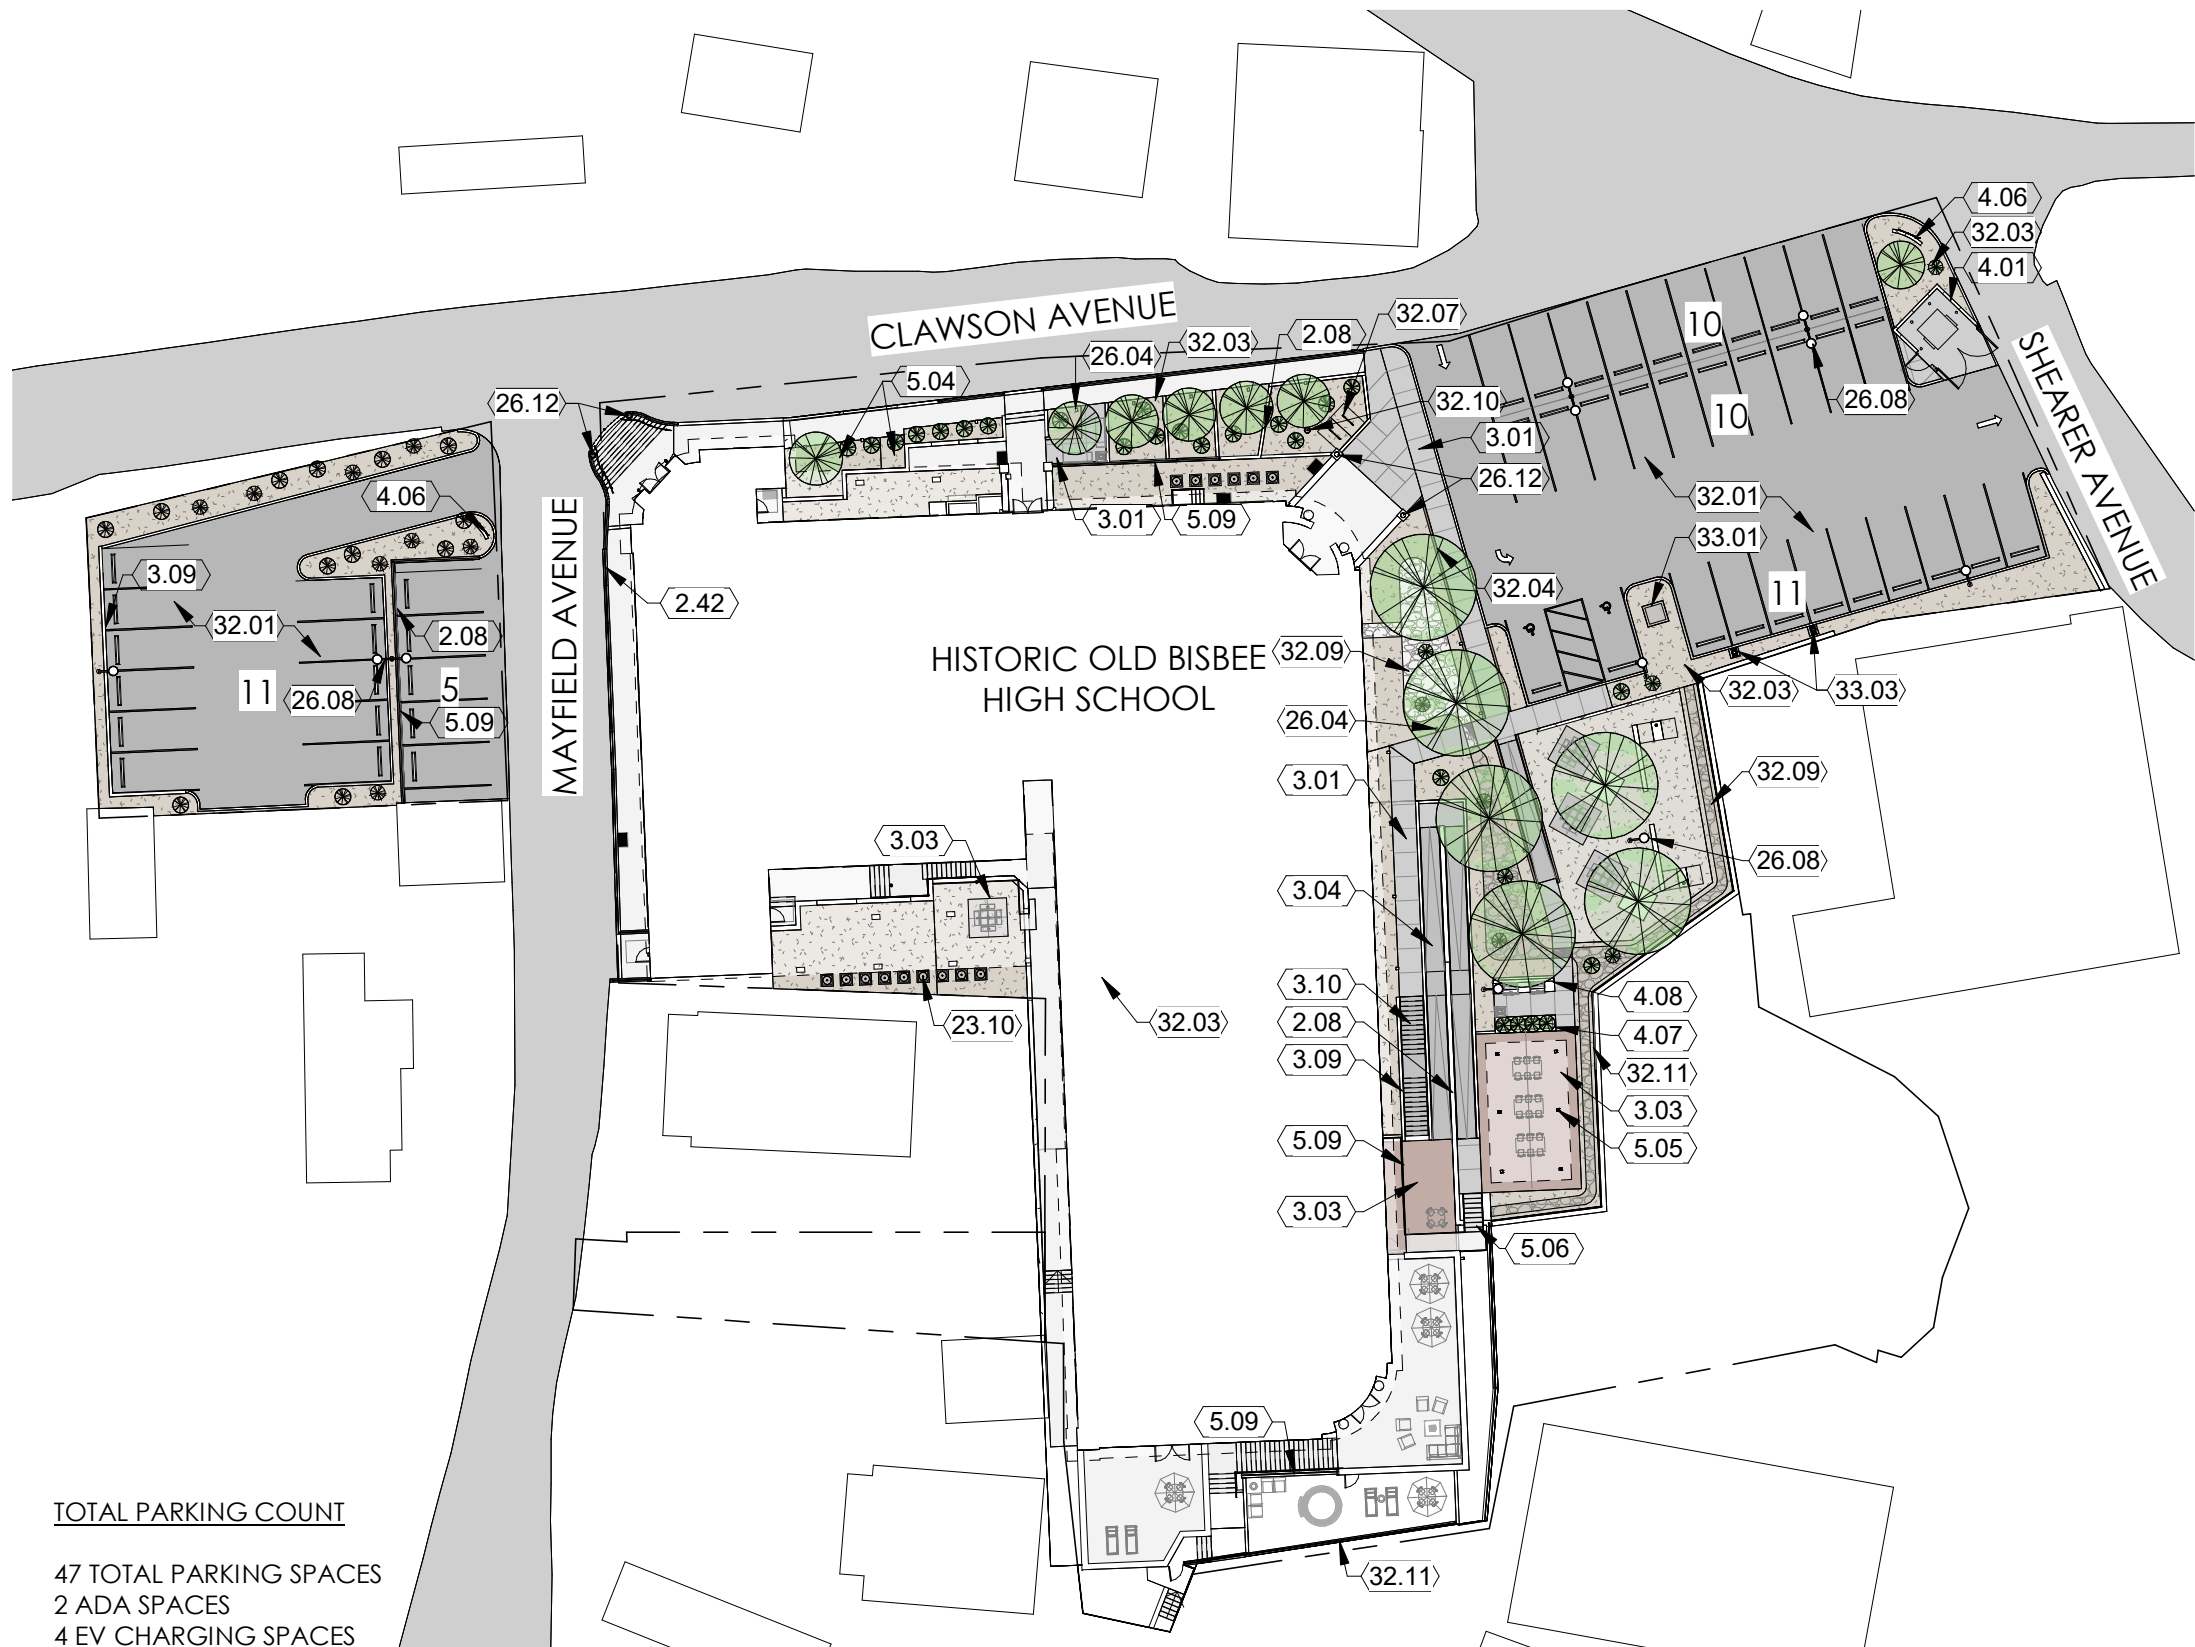
TOTAL PARKING COUNT

47 TOTAL PARKING SPACES  
2 ADA SPACES  
4 EV CHARGING SPACES

- 2.08 EXISTING CONCRETE RETAINING WALL TO REMAIN/ BE PRESERVED - INSPECT FOR REPAIR AS REQUIRED
- 2.42 EXISTING STEEL PIPE RAILING ALONG RETAINING WALL TO REMAIN AND BE PRESERVED FOR REHAB - NOTE PORTIONS THAT REQUIRE EXTENSIVE REPAIR

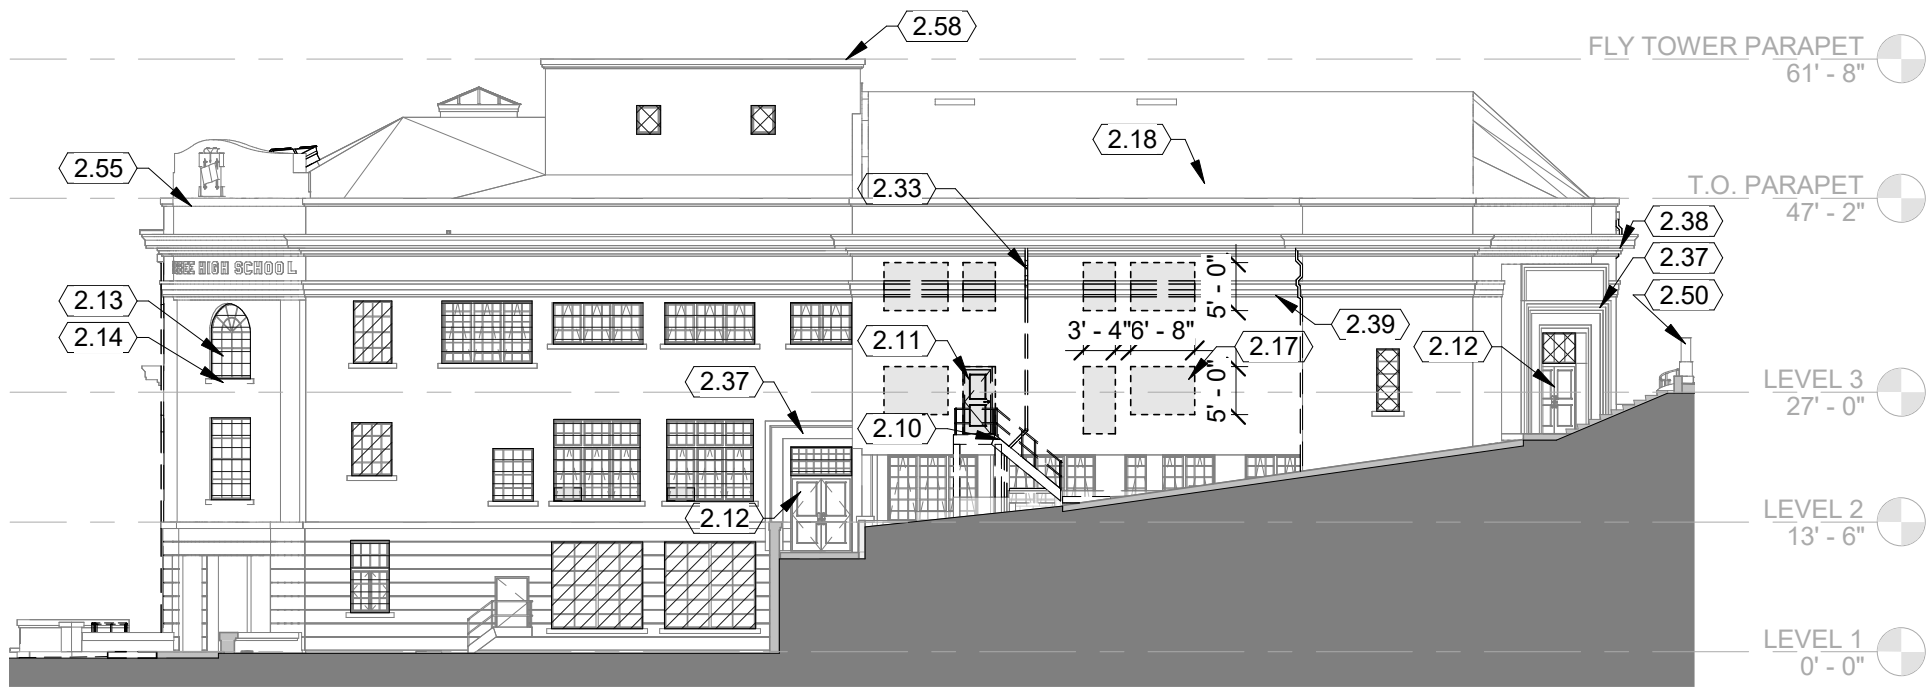
1 NORTH ELEVATION - DEMO - DRB  
SCALE: 1" = 20'-0"

- 2.12 EXISTING DOOR + FRAME TO REMAIN/ BE PRESERVED - SEE DOOR SCHEDULE FOR REHAB SCOPE
- 2.13 EXISTING WINDOW TO REMAIN FOR REPAIR/ REHAB/ UPGRADE WORK - REMOVE ALL WINDOW HVAC UNITS + DUCTWORK

- 2.14 EXISTING CONCRETE WINDOW SILL TO REMAIN/ BE REPAIRED
- 2.17 DEMO FOR NEW OPENING IN EXISTING WALL PER THE NEW WORK PLANS - SEE STRL
- 2.18 EXISTING ROOFING TO BE INSPECTED/ REMOVED/ REPLACED/ REPAIRED AS RECOMMENDED

- 2.21 EXISTING MECHANICAL UNIT/ EQUIPMENT + ASSOCIATED DUCTWORK/ PIPING TO BE DEMOLISHED
- 2.33 EXISTING EXPOSED RAINWATER DOWNSPOUT AND OUTLET AT BASE OF WALL TO BE DEMOLISHED FOR REPLACEMENT TO MATCH

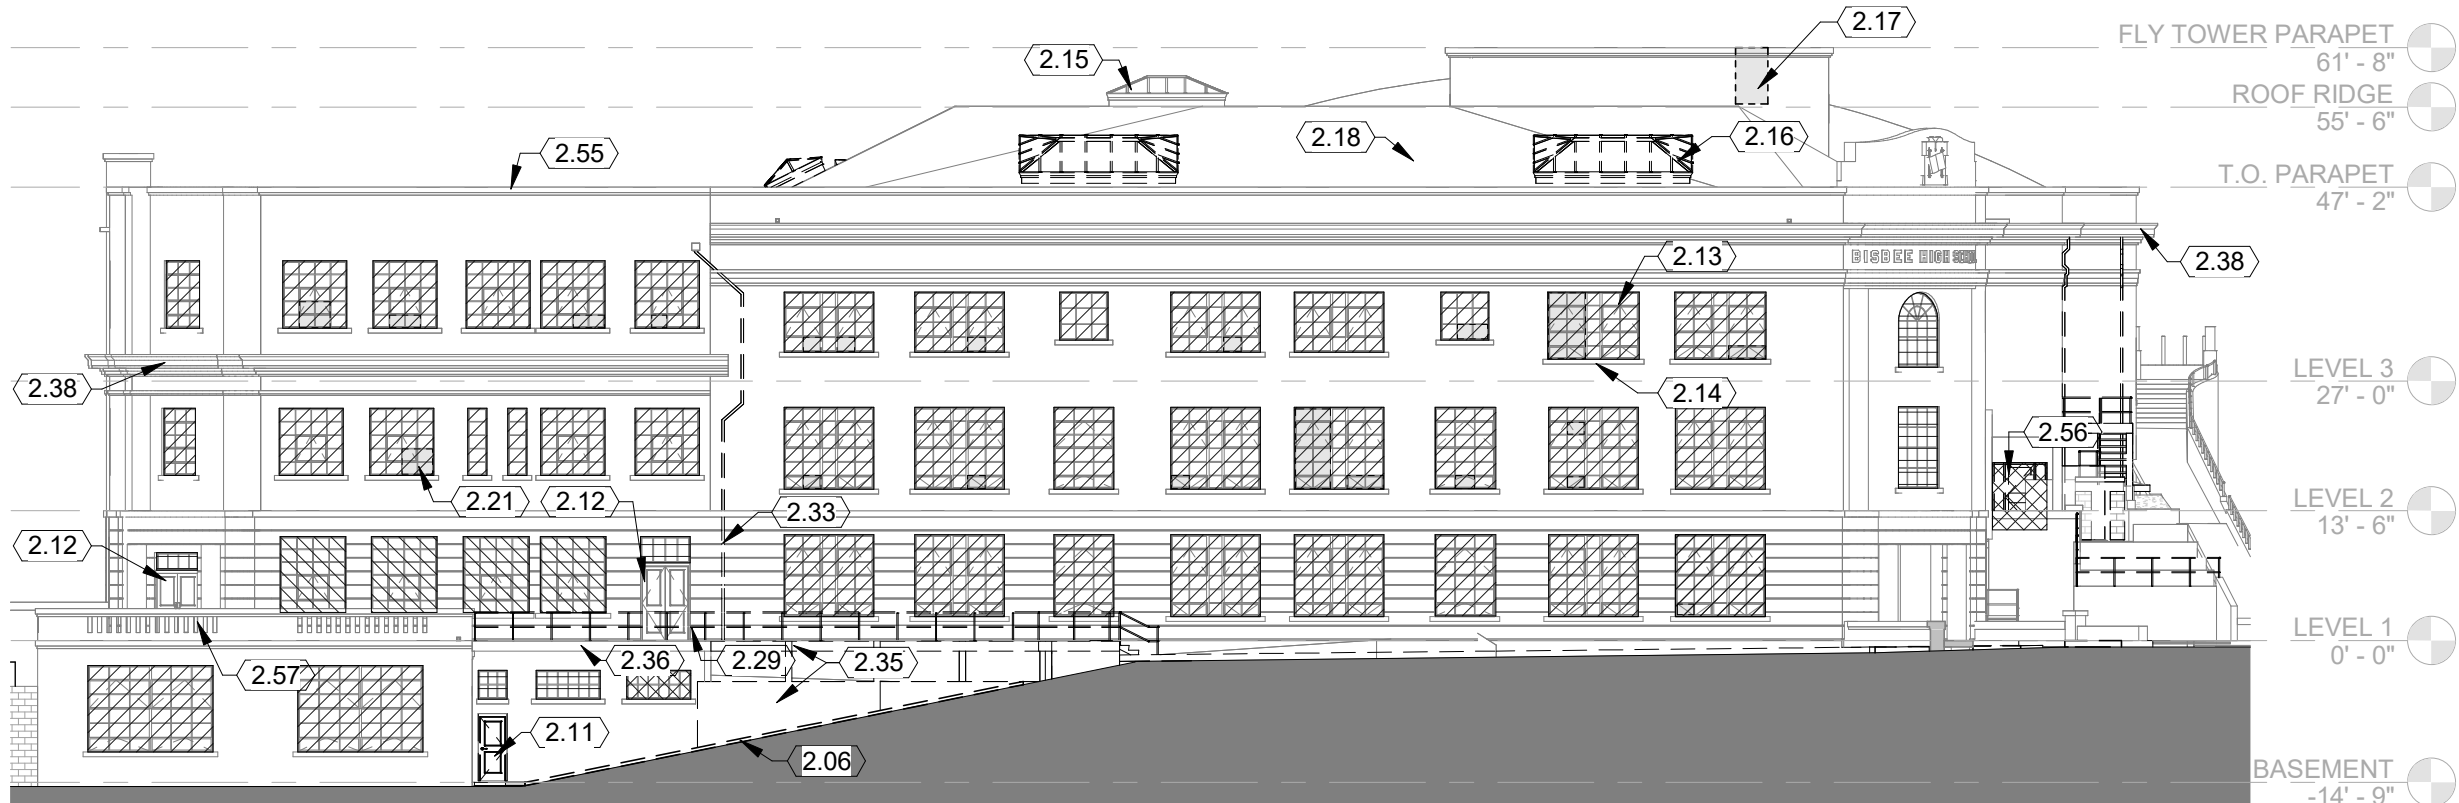
2 EAST ELEVATION - DEMO - DRB  
SCALE: 1" = 20'-0"

- 2.03 EXISTING CONCRETE SIDEWALK OR EXTERIOR SLAB TO REMAIN/ BE PRESERVED - INSPECT FOR REPAIR/REPLACEMENT AS REQUIRED
- 2.06 EXISTING BRICK PAVING TO BE REMOVED + SALVAGED FOR RE-USE PER THE NEW WORK

- 2.13 EXISTING WINDOW TO REMAIN FOR REPAIR/ REHAB/ UPGRADE WORK - REMOVE ALL WINDOW HVAC UNITS + DUCTWORK
- 2.14 EXISTING CONCRETE WINDOW SILL TO REMAIN/ BE REPAIRED

- 2.15 EXISTING SKYLIGHT TO REMAIN FOR REPAIR/ REHAB/ UPGRADE WORK PER NEW WORK PLANS
- 2.16 EXISTING SKYLIGHT TO BE REMOVED - PATCH OPENING PER STRL
- 2.17 DEMO FOR NEW OPENING IN EXISTING WALL PER THE NEW WORK PLANS - SEE STRL

- 2.18 EXISTING ROOFING TO BE INSPECTED/ REMOVED/ REPLACED/ REPAIRED AS RECOMMENDED
- 2.21 EXISTING MECHANICAL UNIT/ EQUIPMENT + ASSOCIATED DUCTWORK/ PIPING TO BE DEMOLISHED

- 2.29 EXISTING STEEL RAILING TO BE DEMOLISHED - SEE NEW PLANS FOR REPLACEMENT

- 2.33 EXISTING EXPOSED RAINWATER DOWNSPOUT AND OUTLET AT BASE OF WALL TO BE DEMOLISHED FOR REPLACEMENT TO MATCH
- 2.35 EXISTING ELEVATED CONCRETE SLAB AND ASSOCIATED SUPPORT WALLS TO BE DEMOLISHED TO THE EXTENT SHOWN - SEE STRL
- 2.36 PORTION OF EXISTING ELEVATED CONCRETE SLAB AND ASSOCIATED SUPPORT WALLS TO REMAIN/ BE PRESERVED
- 2.38 EXISTING METAL CORNICE DETAILING TO REMAIN/ BE PRESERVED
- 2.39 EXISTING EXTERIOR BANDING DETAILING TO REMAIN/ BE PRESERVED
- 2.40 EXISTING STAIRS TO REMAIN/ BE PRESERVED
- 2.55 EXISTING PARAPET TO BE INSPECTED/ REPAIRED AS RECOMMENDED
- 2.56 EXISTING STEEL FRAME STOREFRONT ENTRY TO REMAIN/ BE PRESERVED
- 2.57 EXISTING CONCRETE BALUSTER WALL TO REMAIN/ BE PRESERVED

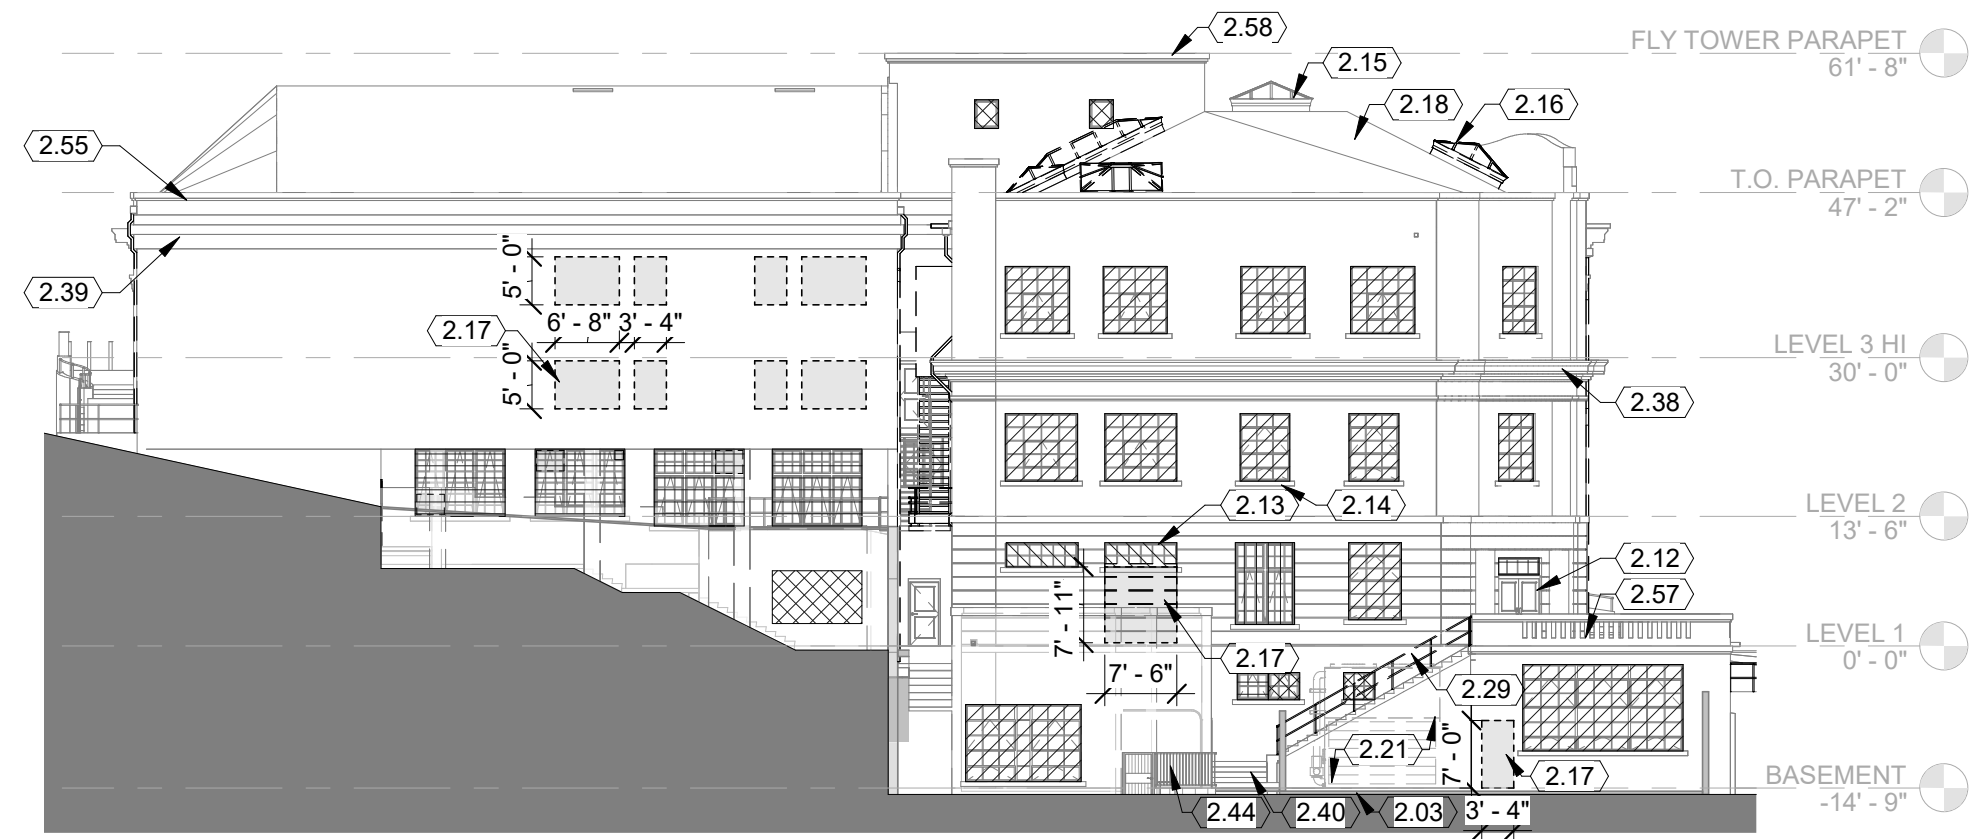
1 SOUTH ELEVATION - DEMO - DRB  
SCALE: 1" = 20'-0"

- 2.03 EXISTING CONCRETE SIDEWALK OR EXTERIOR SLAB TO REMAIN/ BE PRESERVED - INSPECT FOR REPAIR/REPLACEMENT AS REQUIRED
- 2.12 EXISTING DOOR + FRAME TO REMAIN/ BE PRESERVED - SEE DOOR SCHEDULE FOR REHAB SCOPE

- 2.13 EXISTING WINDOW TO REMAIN FOR REPAIR/ REHAB/ UPGRADE WORK - REMOVE ALL WINDOW HVAC UNITS + DUCTWORK
- 2.14 EXISTING CONCRETE WINDOW SILL TO REMAIN/ BE REPAIRED

- 2.15 EXISTING SKYLIGHT TO REMAIN FOR REPAIR/ REHAB/ UPGRADE WORK PER NEW WORK PLANS
- 2.16 EXISTING SKYLIGHT TO BE REMOVED - PATCH OPENING PER STRL
- 2.17 DEMO FOR NEW OPENING IN EXISTING WALL PER THE NEW WORK PLANS - SEE STRL

- 2.18 EXISTING ROOFING TO BE INSPECTED/ REMOVED/ REPLACED/ REPAIRED AS RECOMMENDED
- 2.21 EXISTING MECHANICAL UNIT/ EQUIPMENT + ASSOCIATED DUCTWORK/ PIPING TO BE DEMOLISHED

- 2.29 EXISTING STEEL RAILING TO BE DEMOLISHED - SEE NEW PLANS FOR REPLACEMENT
- 2.38 EXISTING METAL CORNICE DETAILING TO REMAIN/ BE PRESERVED
- 2.39 EXISTING EXTERIOR BANDING DETAILING TO REMAIN/ BE PRESERVED

- 2.40 EXISTING STAIRS TO REMAIN/ BE PRESERVED
- 2.44 EXISTING GATE AND FENCING TO REMAIN/ BE PRESERVED
- 2.55 EXISTING PARAPET TO BE INSPECTED/ REPAIRED AS RECOMMENDED
- 2.57 EXISTING CONCRETE BALUSTER WALL TO REMAIN/ BE PRESERVED
- 2.58 EXISTING METAL COPING TO BE INSPECTED/ REPAIRED AS RECOMMENDED

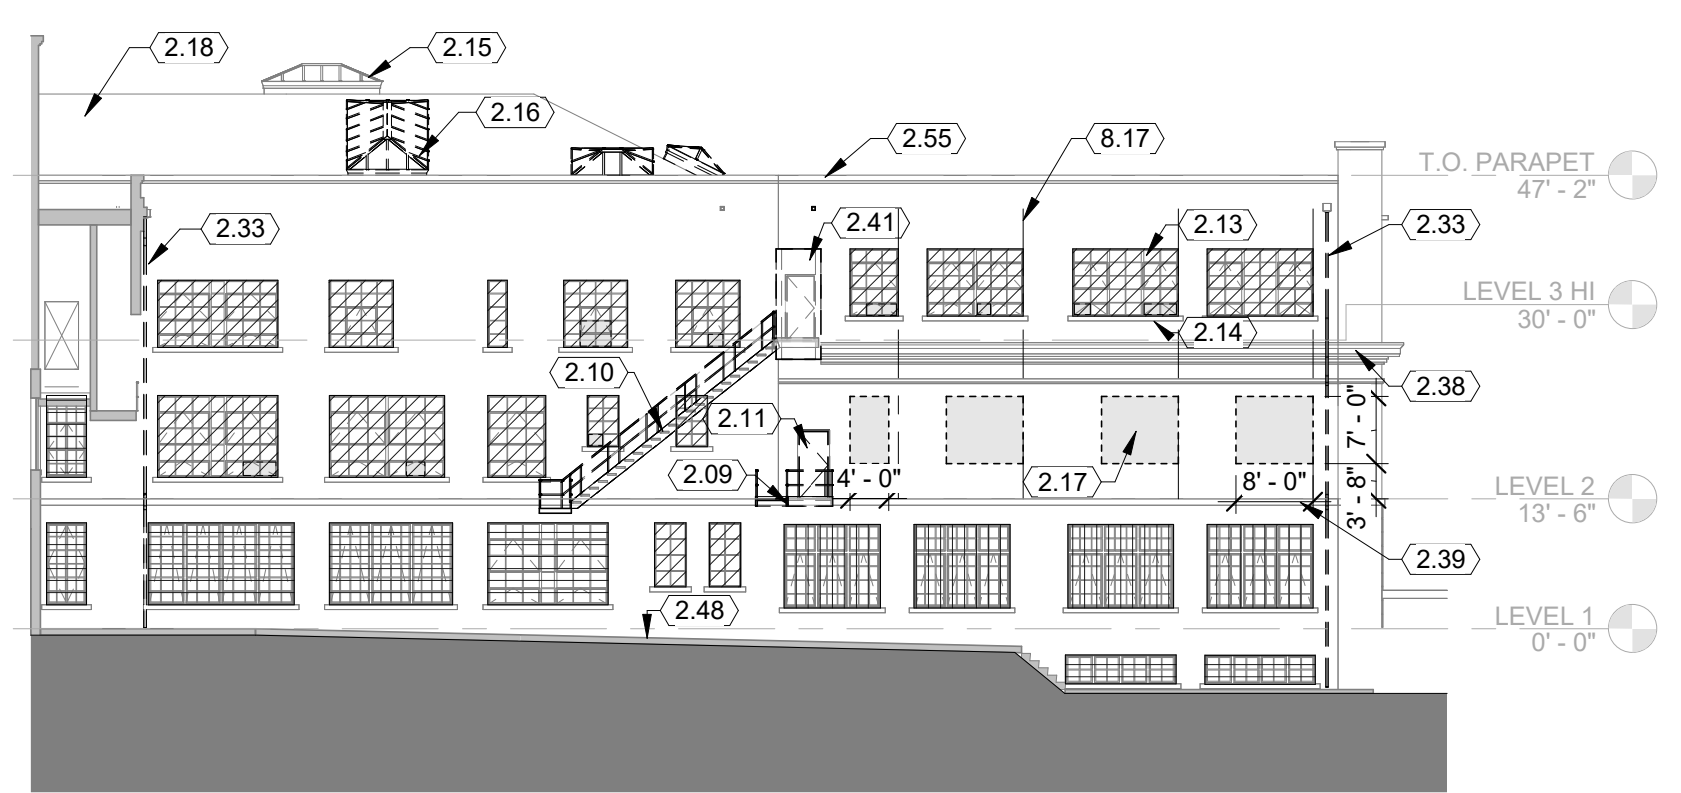
2 WEST ELEVATION - DEMO - DRB  
SCALE: 1" = 20'-0"

- 2.03 EXISTING CONCRETE SIDEWALK OR EXTERIOR SLAB TO REMAIN/ BE PRESERVED - INSPECT FOR REPAIR/REPLACEMENT AS REQUIRED
- 2.08 EXISTING CONCRETE RETAINING WALL TO REMAIN/ BE PRESERVED - INSPECT FOR REPAIR AS REQUIRED

- 2.13 EXISTING WINDOW TO REMAIN FOR REPAIR/ REHAB/ UPGRADE WORK - REMOVE ALL WINDOW HVAC UNITS + DUCTWORK
- 2.14 EXISTING CONCRETE WINDOW SILL TO REMAIN/ BE REPAIRED

- 2.15 EXISTING SKYLIGHT TO REMAIN FOR REPAIR/ REHAB/ UPGRADE WORK PER NEW WORK PLANS
- 2.16 EXISTING SKYLIGHT TO BE REMOVED - PATCH OPENING PER STRL
- 2.17 DEMO FOR NEW OPENING IN EXISTING WALL PER THE NEW WORK PLANS - SEE STRL

- 2.18 EXISTING ROOFING TO BE INSPECTED/ REMOVED/ REPLACED/ REPAIRED AS RECOMMENDED

- 2.33 EXISTING EXPOSED RAINWATER DOWNSPOUT AND OUTLET AT BASE OF WALL TO BE DEMOLISHED FOR REPLACEMENT TO MATCH
- 2.37 EXISTING ARCHITRAVE DETAILING TO REMAIN/ BE PRESERVED
- 2.38 EXISTING METAL CORNICE DETAILING TO REMAIN/ BE PRESERVED
- 2.39 EXISTING EXTERIOR BANDING DETAILING TO REMAIN/ BE PRESERVED
- 2.40 EXISTING STAIRS TO REMAIN/ BE PRESERVED
- 2.41 EXISTING NON-ORIGINAL STAIR LANDING ENCLOSURE STRUCTURE TO BE DEMOLISHED IN ITS ENTIRETY
- 2.42 EXISTING STEEL PIPE RAILING ALONG RETAINING WALL TO REMAIN AND BE PRESERVED FOR REHAB - NOTE PORTIONS THAT REQUIRE EXTENSIVE REPAIR
- 2.48 EXISTING CONCRETE DRAINAGE AREA - CLEAR OF ALL DEBRIS AND REPAIR DAMAGED SECTIONS TO ENSURE POSITIVE DRAINAGE
- 2.55 EXISTING PARAPET TO BE INSPECTED/ REPAIRED AS RECOMMENDED
- 8.17 ALIGN NEW WINDOWS WITH EXISTING AS SHOWN - FIELD VERIFY DIMENSIONS BEFORE CUTTING EXISTING WALL

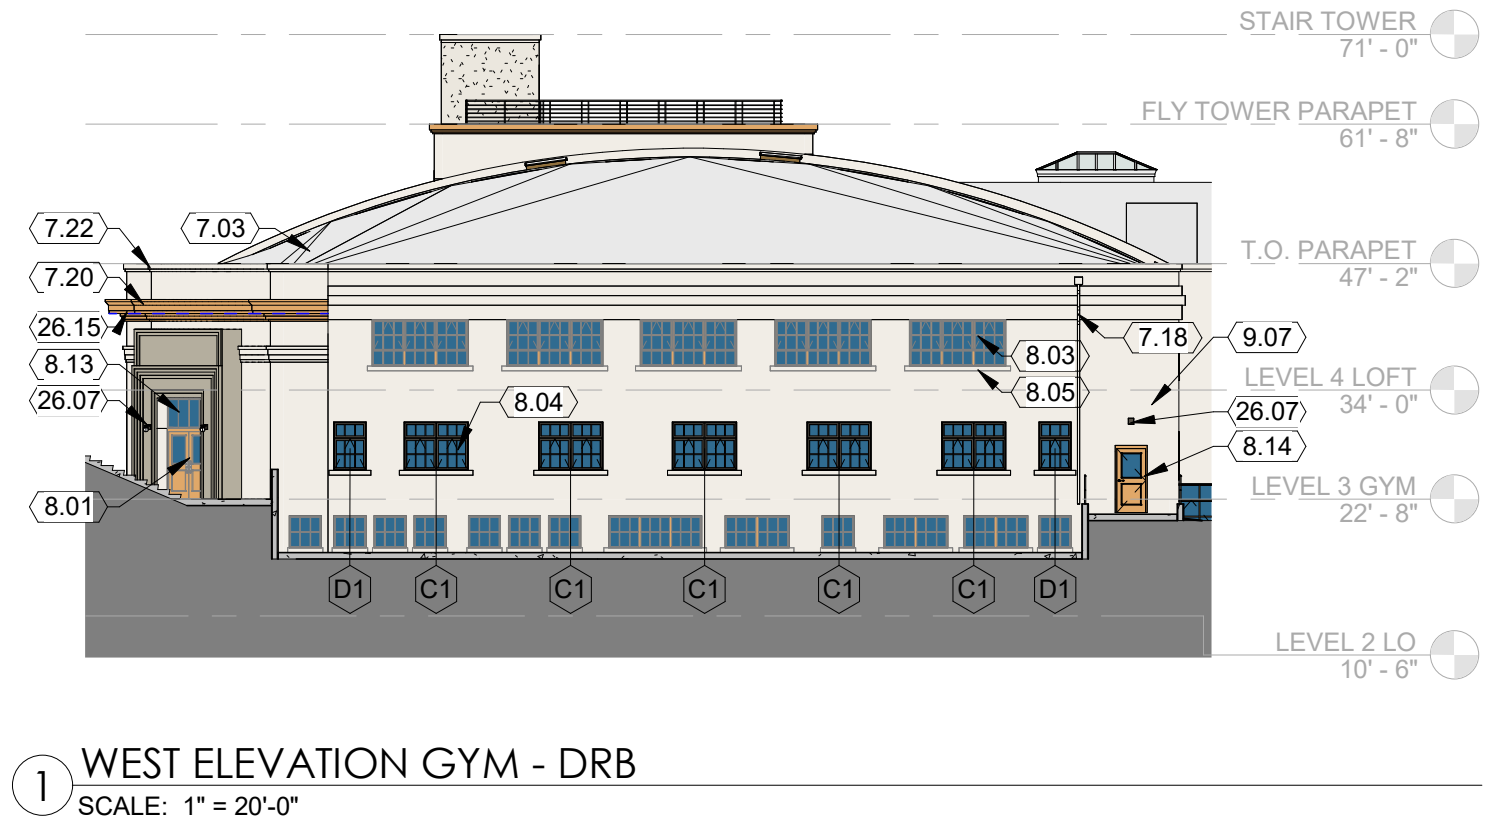
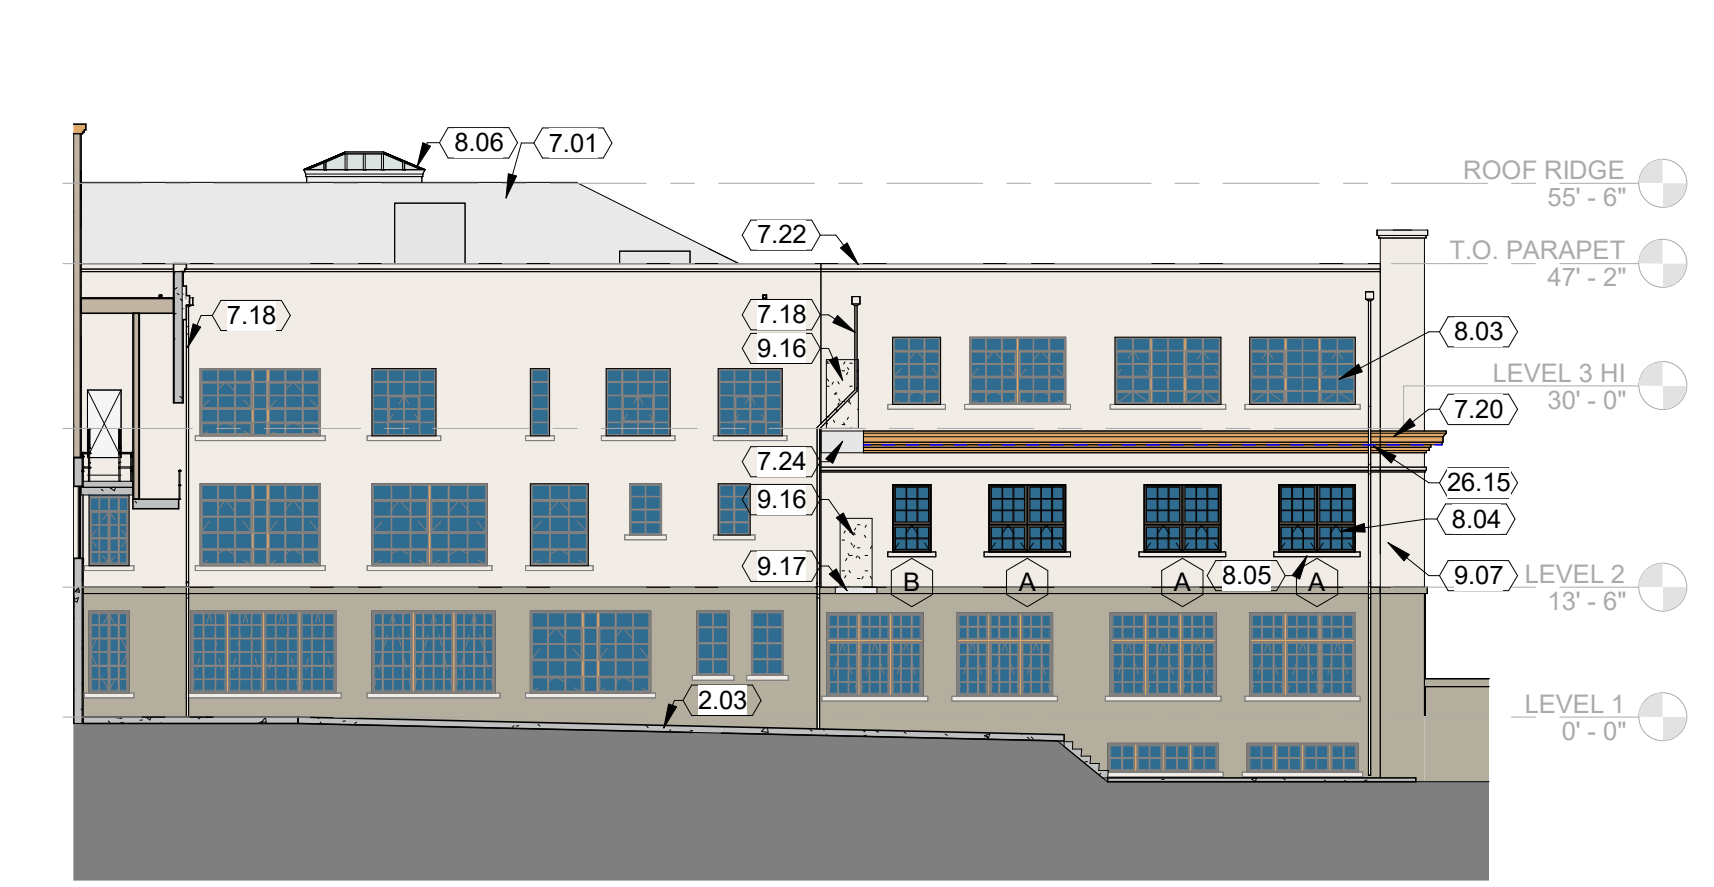
- 2.03 EXISTING CONCRETE SIDEWALK OR EXTERIOR SLAB TO REMAIN/ BE PRESERVED - INSPECT FOR REPAIR/REPLACEMENT AS REQUIRED
- 7.01 SLOPED ROOF - REHAB/RECOAT ROOFING AS RECOMMENDED
- 7.03 CURVED ROOF - REHAB/RECOAT ROOFING AS RECOMMENDED
- 7.18 NEW SHEET METAL CONDUCTOR HEAD AND/OR DOWNSPOUT
- 7.20 EXISTING METAL CORNICE DETAIL - REHAB/REPLACE DAMAGED SECTIONS - NEW ELASTOMERIC COATING AT TOP SURFACE
- 7.22 EXISTING PARAPET - REHAB/REPLACE DAMAGED SECTIONS - NEW ELASTOMERIC COATING AT TOP SURFACE
- 7.24 VERIFY EDGE OF CORNICE CONDITION AND REPAIR/ REPLACE/ TERMINATE WITH NEW SHEET METAL TO MATCH AS REQUIRED

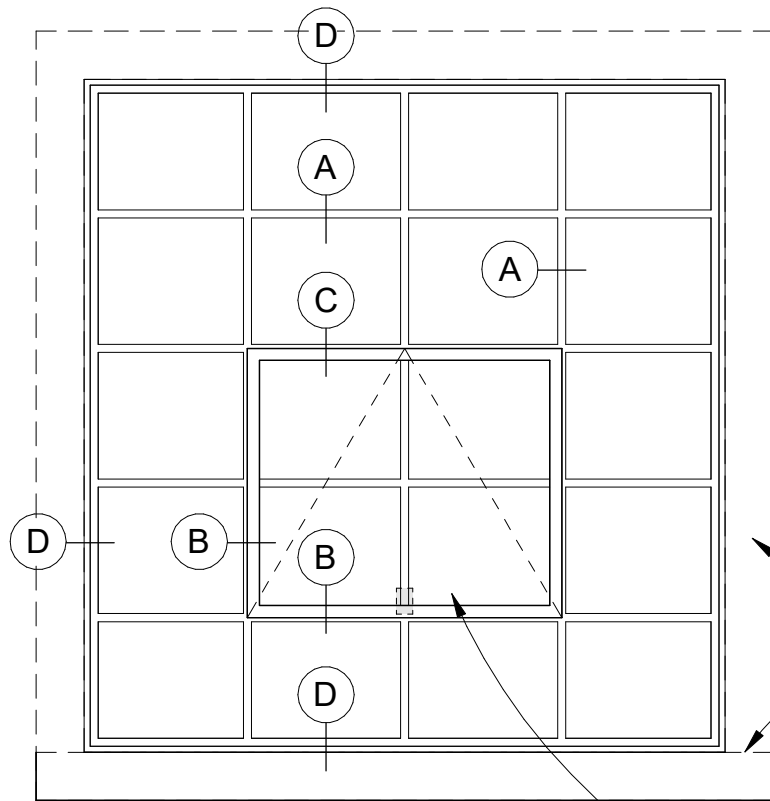
NOTE: SEE STEEL SASH DETAILS THIS SHEET. EXISTING WINDOWS ARE A MIX OF INTERIOR AND EXTERIOR CLAZED CONFIGURATIONS. ONLY INTERIOR GLAZED WINDOW IS DETAILED - THE SAME NOTES APPLY TO AN EXTERIOR GLAZED WINDOW, AND THEY SHARE THE SAME OPERATION PROCEDURES.

NOTE SILL/ JAMB/ HEAD CONDITION VARIES - LATER-INSTALLED STEEL SASH REPLACED ORIGINAL WOOD WINDOWS BUT OFTEN AT A SMALLER DIMENSION WITH A NARROWER MASONRY + PLASTER INFILL SURROUND

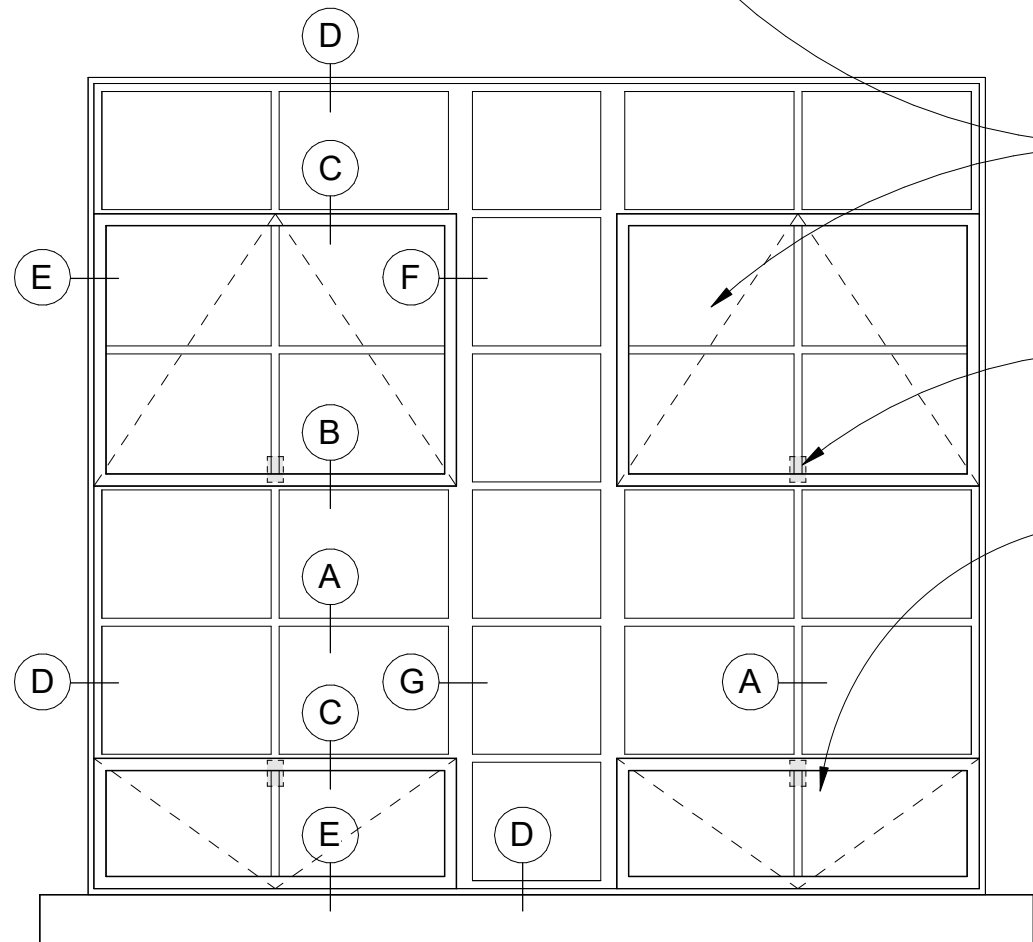
OUT-SWING AWNING TO REMAIN AND BE REHABILITATED FOR SMOOTH AND STABLE OPERATION AND FULL WEATHERSEALED CLOSURE

REFURBISH AND LUBRICATE EXISTING HARDWARE (PULLS, LOCKS, SLIDES, HINGES, EXTENSION RODS, ETC. - PROVIDE NEW WHERE MISSING

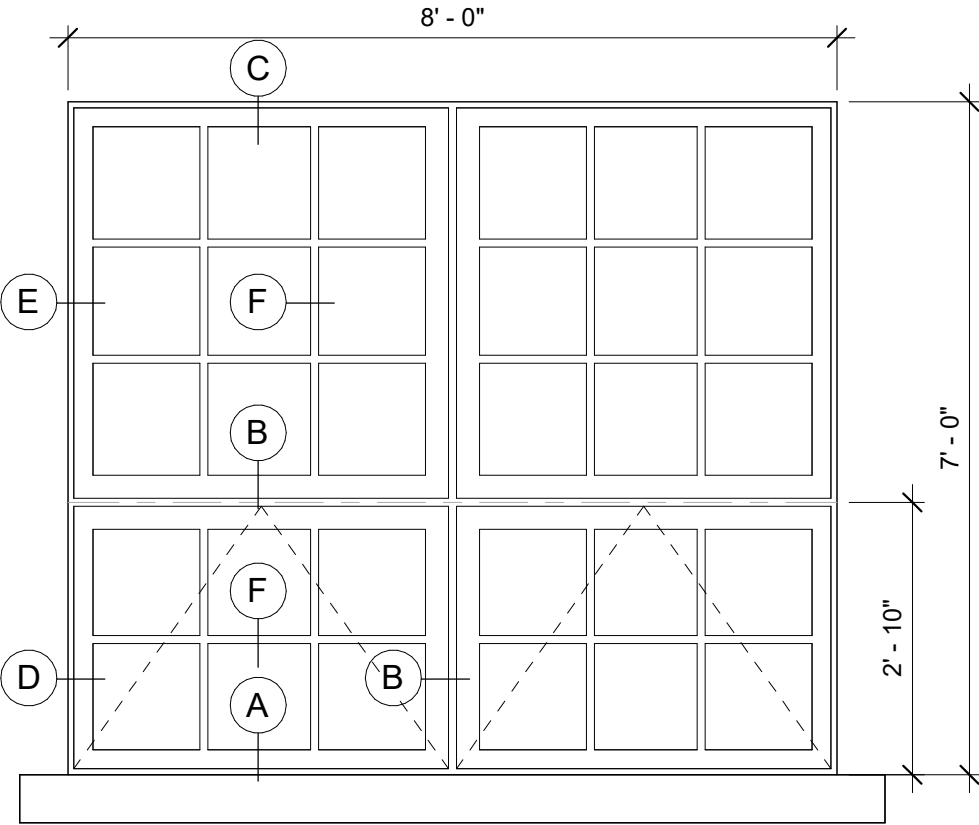
**A**  
LEVEL 2  
ALUMINUM-CLAD WOOD  
FIXED + AWNING

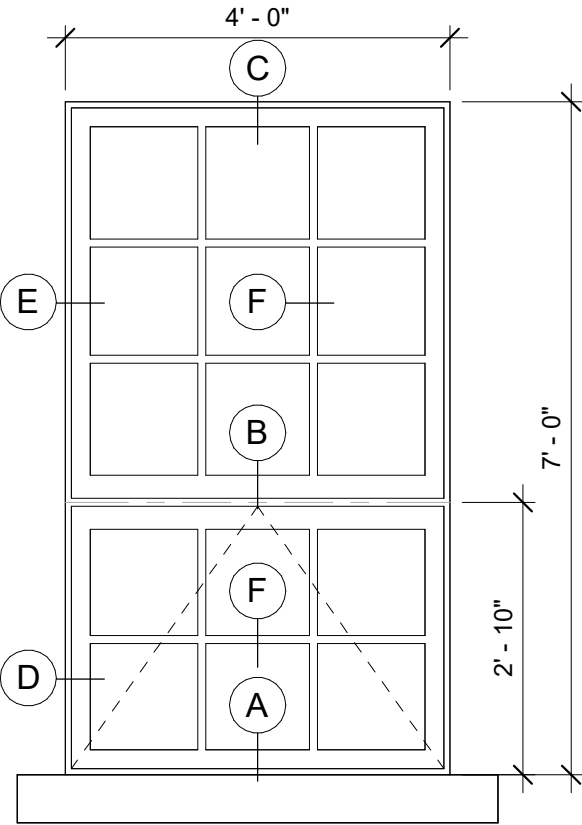
**B**  
LEVEL 2  
ALUMINUM-CLAD WOOD  
FIXED + AWNING

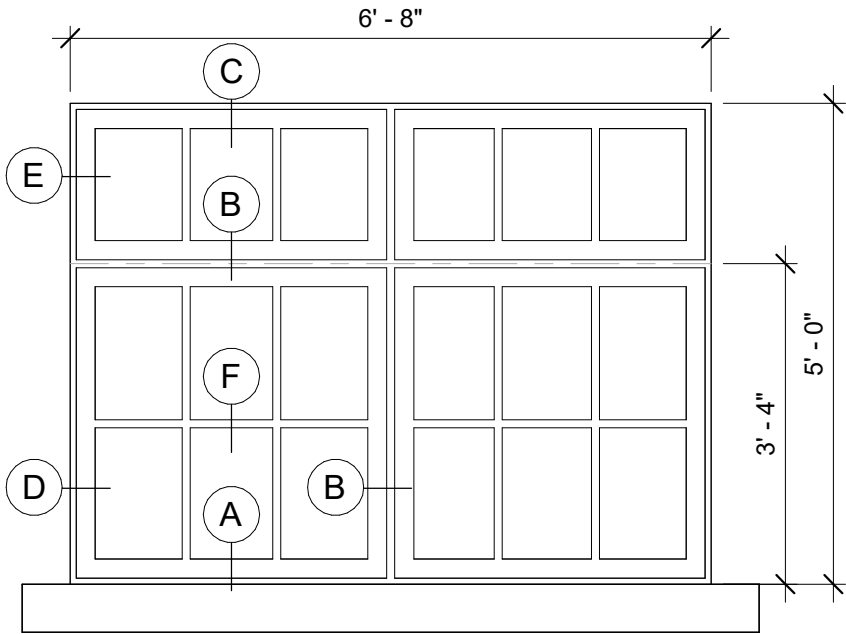
**C2**  
GYM LOFT - UPPER  
ALUMINUM-CLAD WOOD  
FIXED

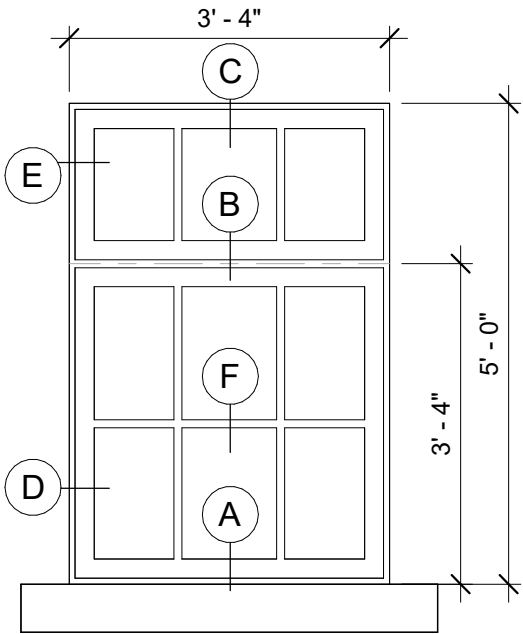
**D2**  
GYM LOFT - UPPER  
ALUMINUM-CLAD WOOD  
FIXED

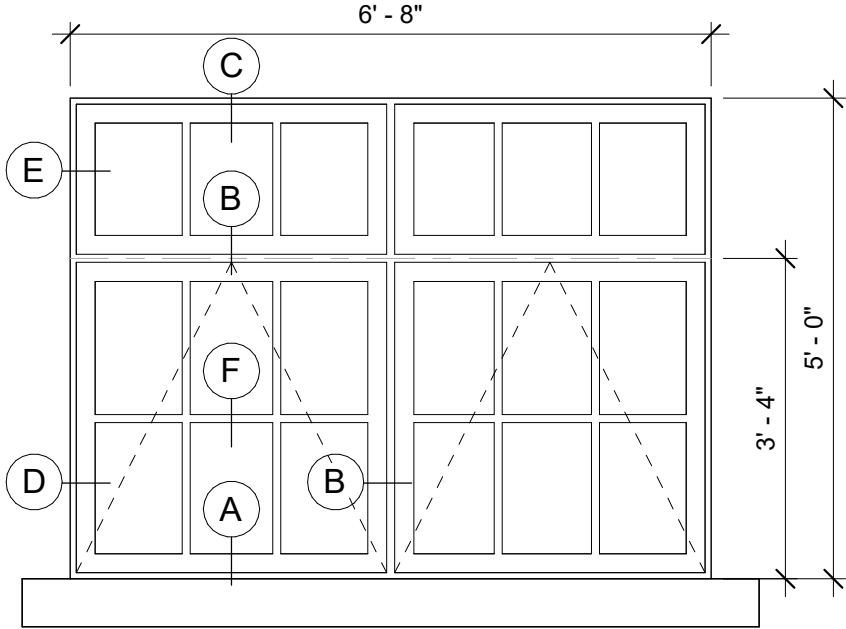
**C1**  
GYM LOFT - LOWER  
ALUMINUM-CLAD WOOD  
FIXED + AWNING
