# OLD BISBEE HIGH LOFTS

DESIGN REVIEW BOARD  
APPLICATION PACKAGE  
SUBMISSION

100 CLAWSON AVENUE  
BISBEE, ARIZONA 85603

APRIL, 2023

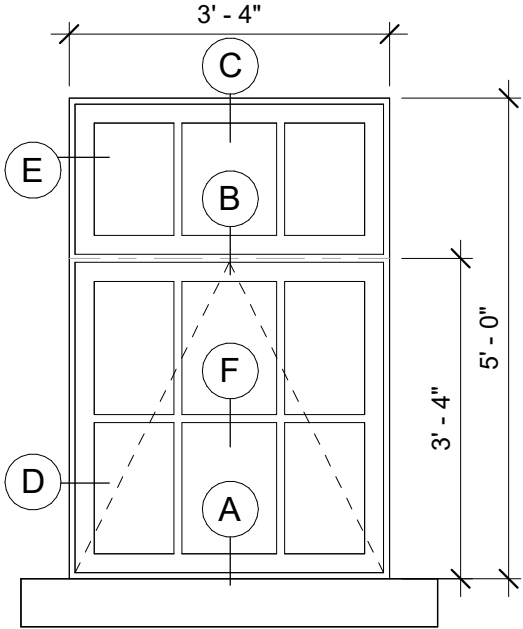
**D1**  
GYM LOFT - LOWER  
ALUMINUM-CLAD WOOD  
FIXED + AWNING

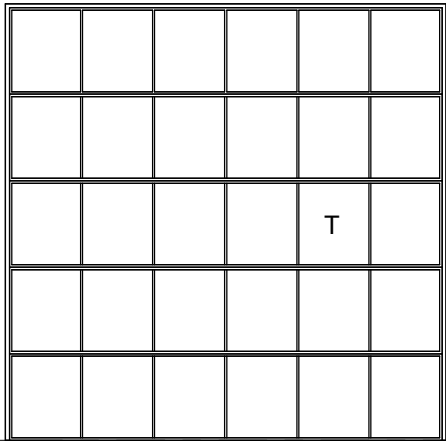
G-G

EXTERIOR  
INSULATED GLASS PANEL  
ALUMINUM FRAME
